Manhole Inspection Summary

Manhole # S07QQ1024MH

Insp Date: **1/20/09 3:39 PM**

Location Address: **5272 PARK HIEGHTS AVE**

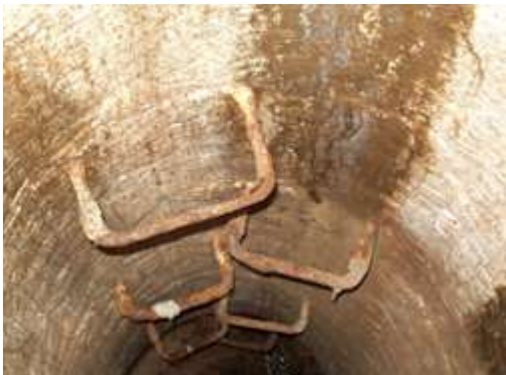
Defect 1

Count: **7** Missing: **0** ☒ **Corroded**

CORROED STEPS

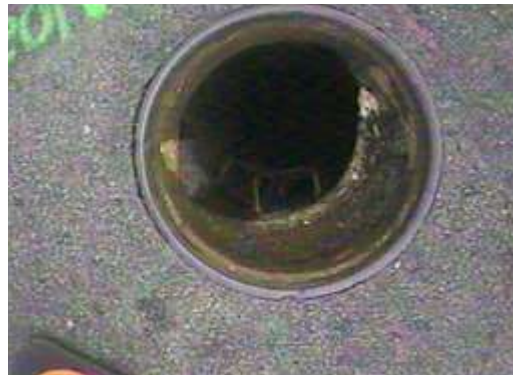
Defect 2

Offset: **5** (in.)

FRAME OFFSET

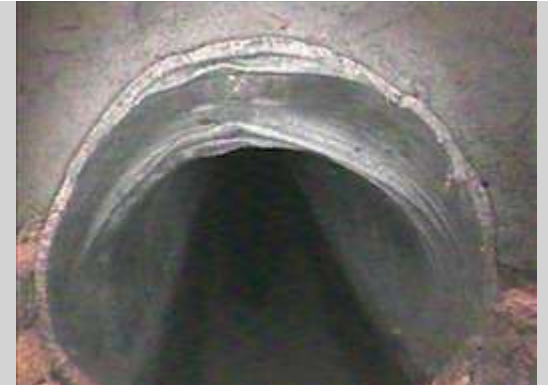
12 O'Clock Outflow

12 in. Circular Gravity Sewer
Pipe Out @ 12 O'Clock

Invert Depth: **14.17** (ft.) Flow Characteristics: **Slow**

Infiltration: **None** Pipe Seal Cond: **Sound**

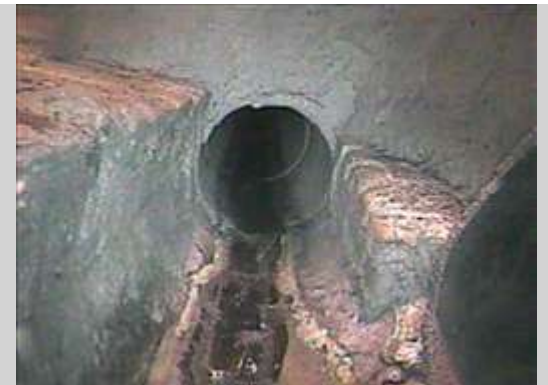
6 O'Clock Inflow

8 in. Circular Gravity Sewer
Pipe In @ 6 O'Clock

Invert Depth: **13.98** (ft.) Flow Characteristics: **Slow**

Infiltration: **None** Pipe Seal Cond: **Sound**

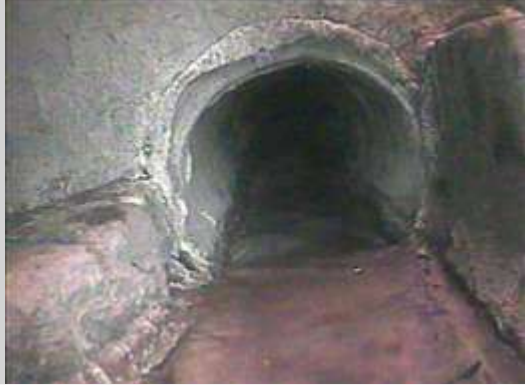
8 O'Clock Inflow

12 in. Circular Gravity Sewer
Pipe In @ 8 O'Clock

Invert Depth: **14.12** (ft.) Flow Characteristics: **Slow**

Infiltration: **None** Pipe Seal Cond: **Sound**
